JOINT TASK FORCE ONE

ARMY GROUND GROUP
(TASK GROUP 1.4)

FINAL REPORT

ATOMIC BOMB TESTS

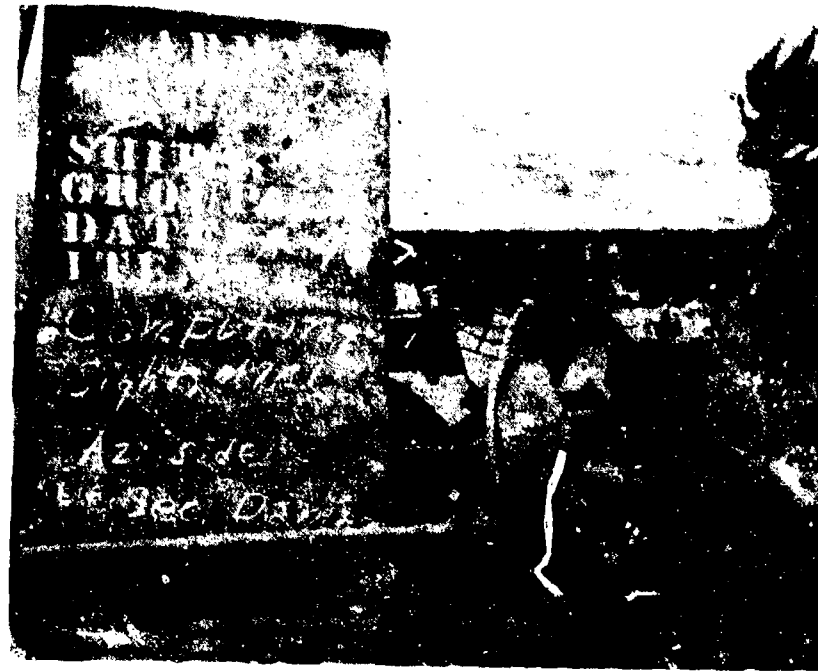
Fig. 81 -- USS Arkansas - Computing Sight, M7A1 on
40mm Gun, M1 - Secondary damage, from falling
cable, to ring sight on right side.

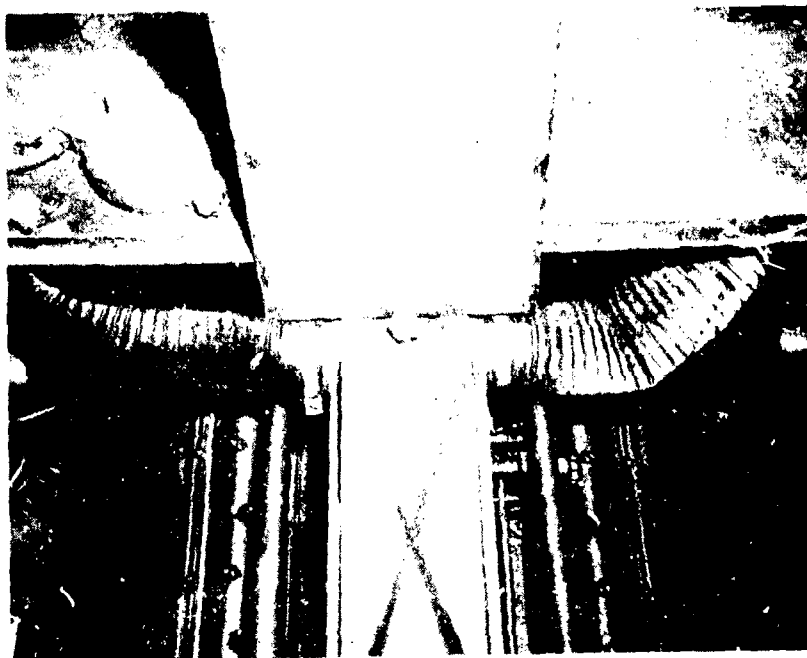
Fig. 117 - USS Nevada - Carriage, Motor, 90mm Gun, M36 - View after Test Able showing damage to engine air cleaner hoses.

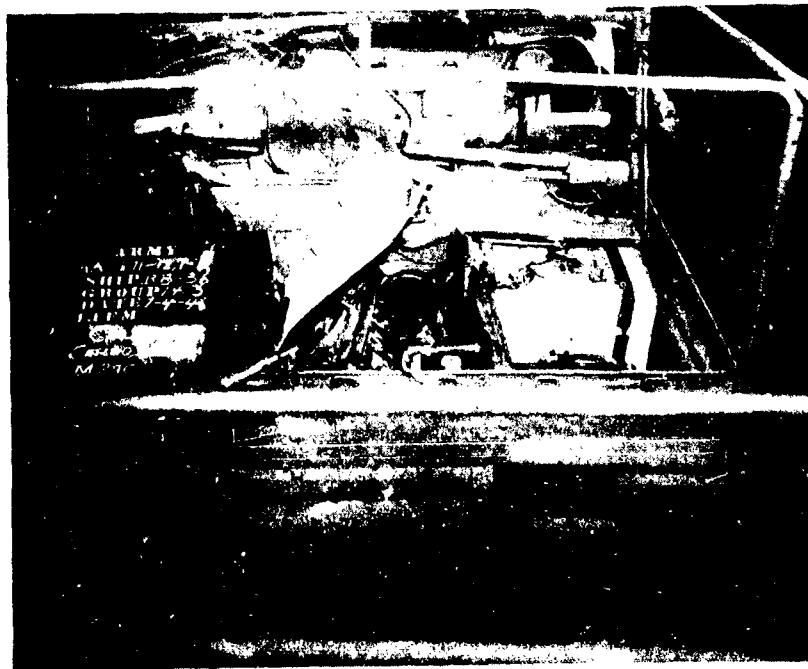
Fig. 120 - USS Nevada - Carrier, Cargo, M29C - Damage from Test Able.

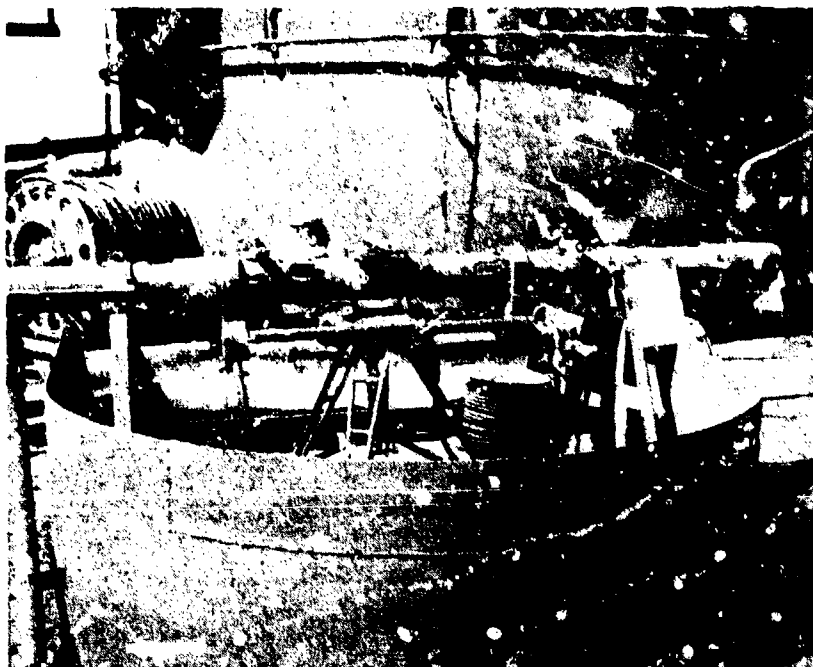
Fig. 181 - USS Arkansas - Height Finder, M1A1 - Front view after Test Able. Note missing eyeguards and sun shield cover.

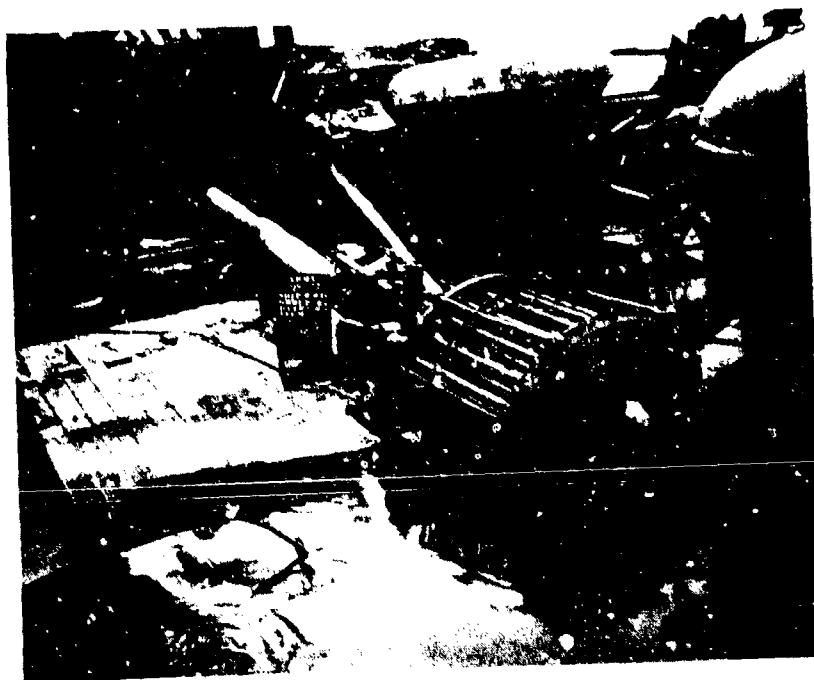
Fig. 197 - USS Nevada - Gun, 75mm, AC, M10 - Damage
from Test Able. Note condition of the deck
below the piece.

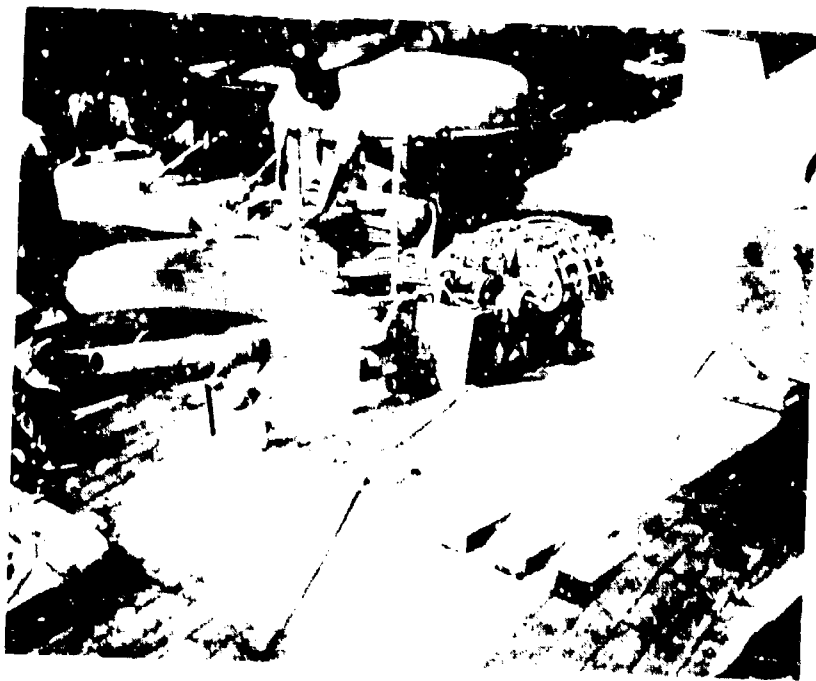
Fig. 198 - USS Nevada - Gun, 75 mm, AC, M10 - Damage from Test Able. Note condition of the deck below the piece.

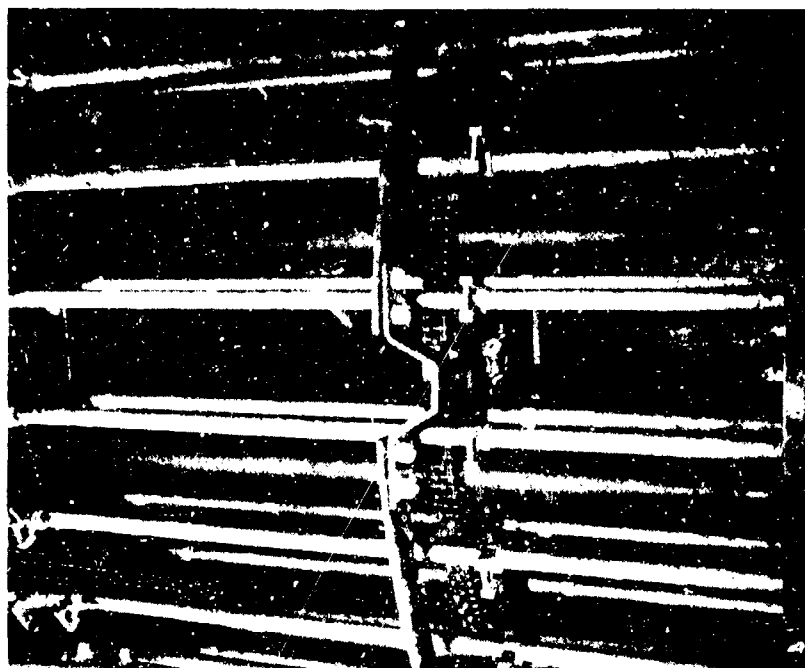
Fig. 201 - USS Nevada - Gun, 75mm, AC, M10 -
View showing broken loading tray.

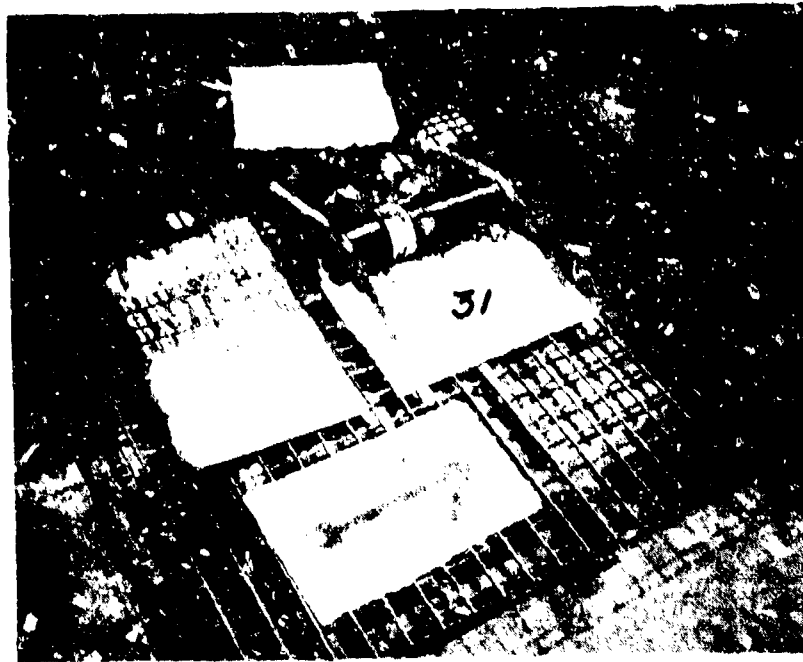
Fig. 247 - YOG 83 - Damage to Item 31 after Test Able.

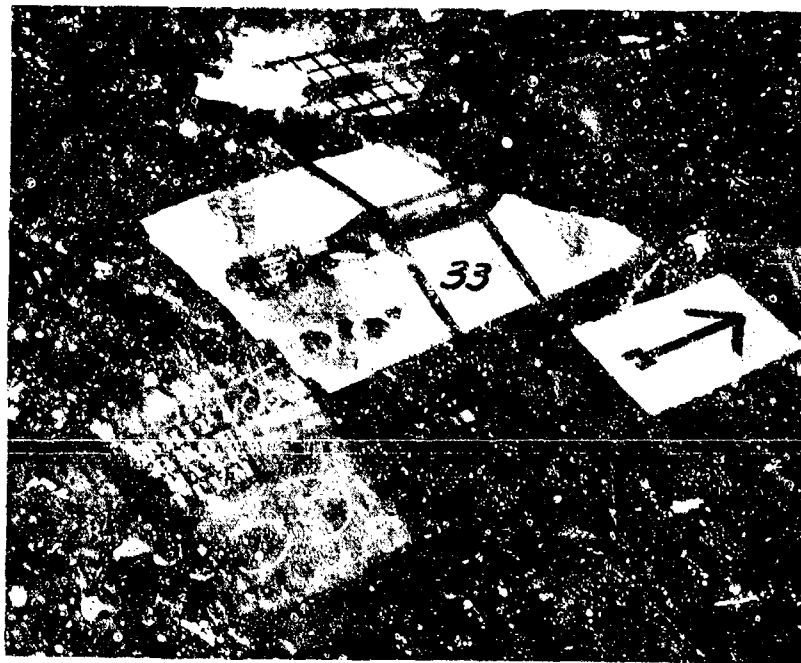
Fig. 250 - YOG 83 - Damage to Item 33 after Test Able.

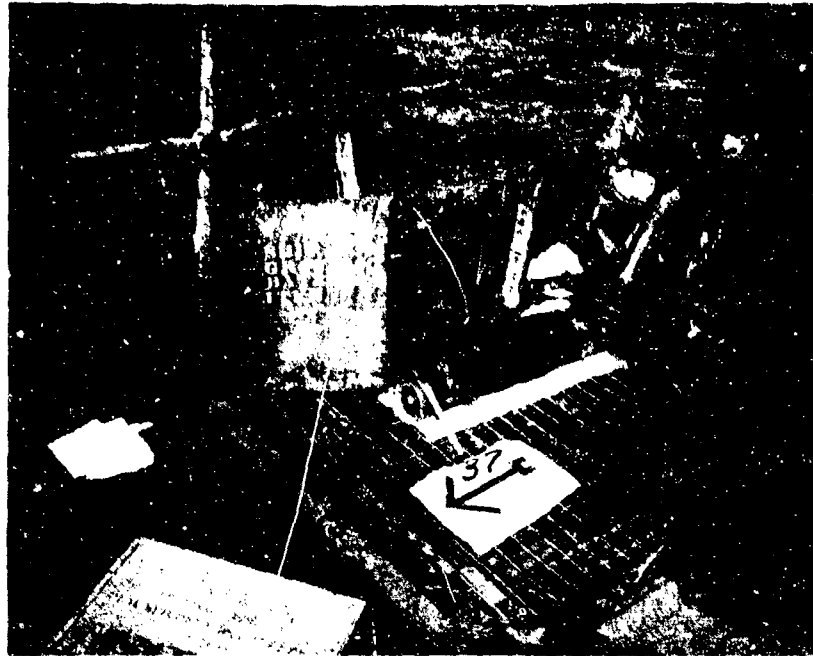
Fig. 257 - YOG 83 - Damage to Item 37 after Test Able.

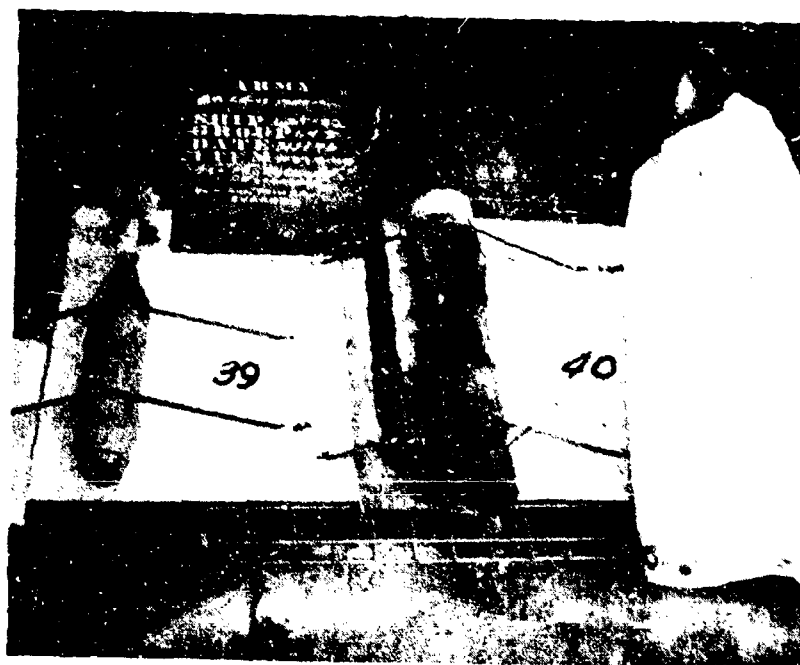
Fig. 262 - LST 52 - Damage to Items 39 and 40 after Test Able.

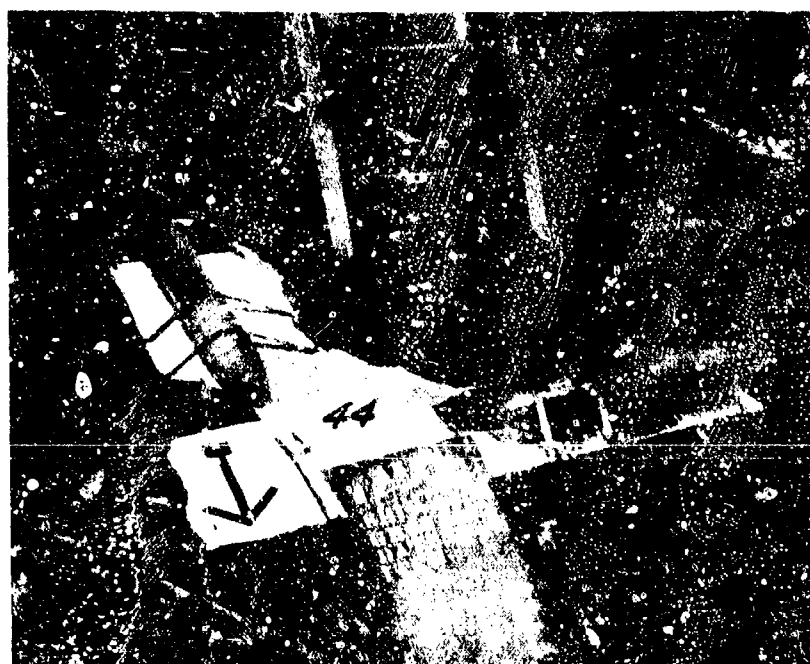
Fig. 268 - YOG 83 - Damage to Item 44 after Test Able.

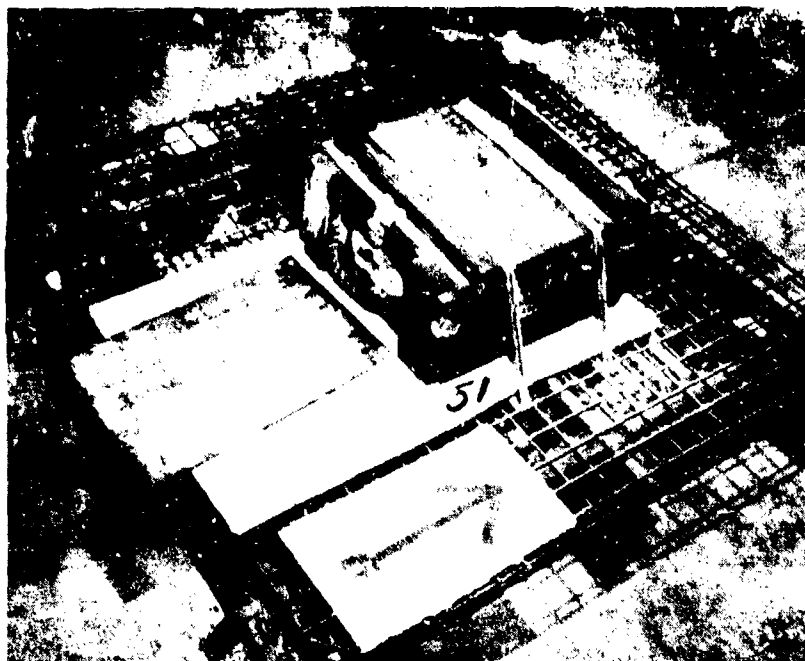
Fig. 287 - YOG 83 - Damage to Item 51 after Test Able.

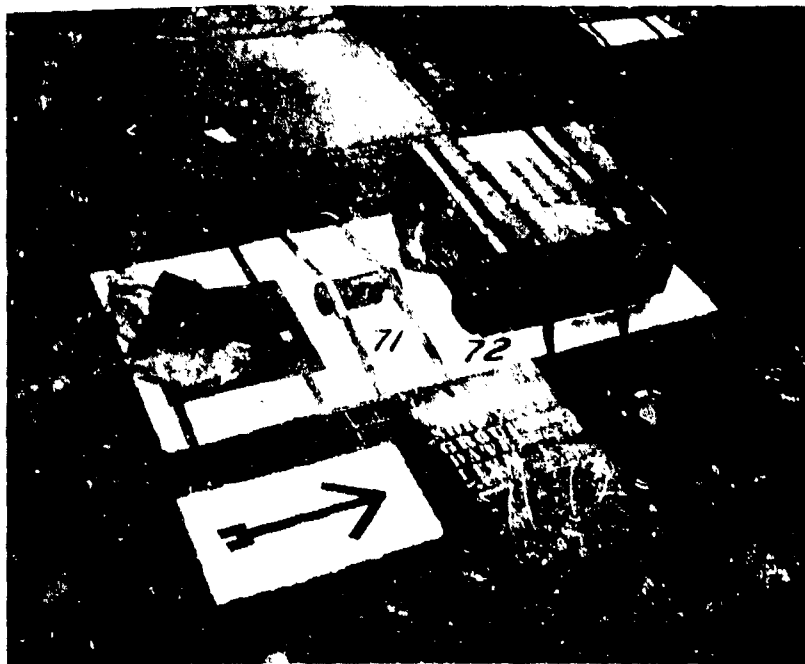
Fig. 311 - YOG 83 - Damage to Items 71 and 72 after Test Able.

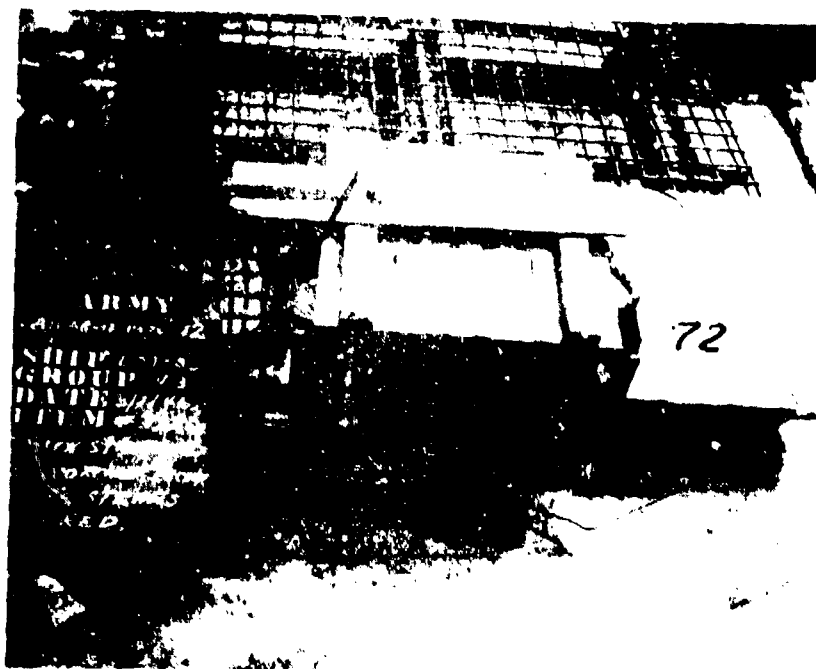
Fig. 313 - LST 52 - View of Item 72 after Test Able showing mask marks and broken strapping.

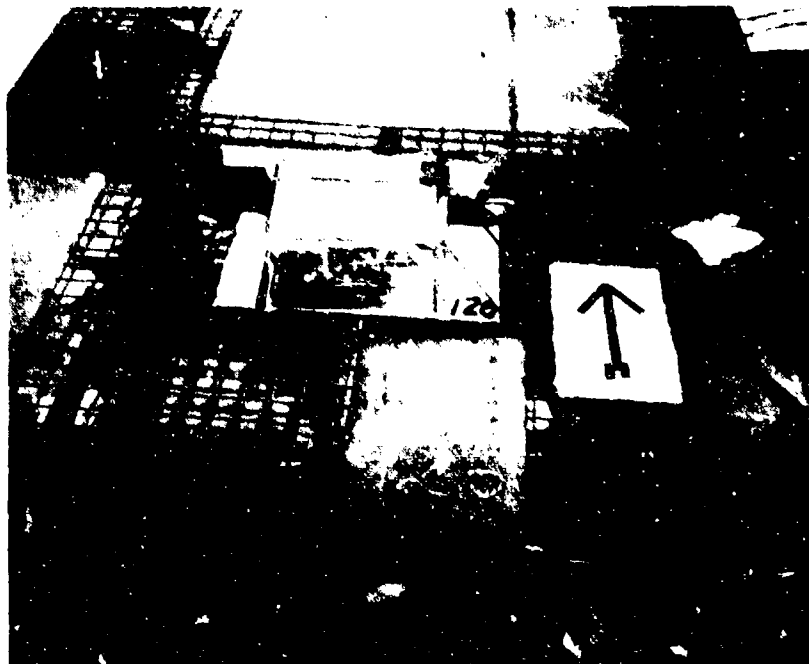
Fig. 345 - YOG 83 - Damage to Item 126 after Test Able.

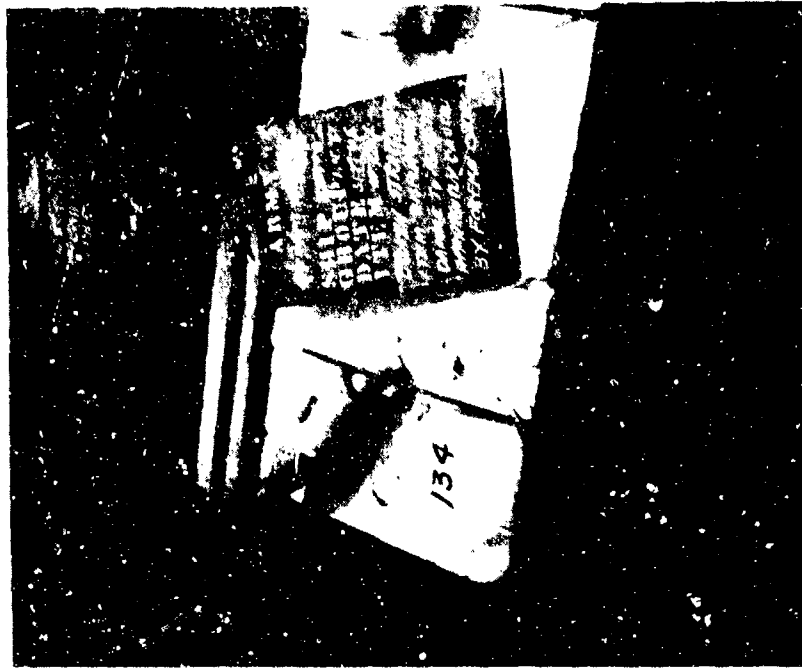
Fig. 358 - LST 52 - Damage to Item 134
after Test Able.
